S19 Flood Investigation

Storm Kathleen - Littlehampton, April 2024

REPORT (VERSION1) PUBLIC

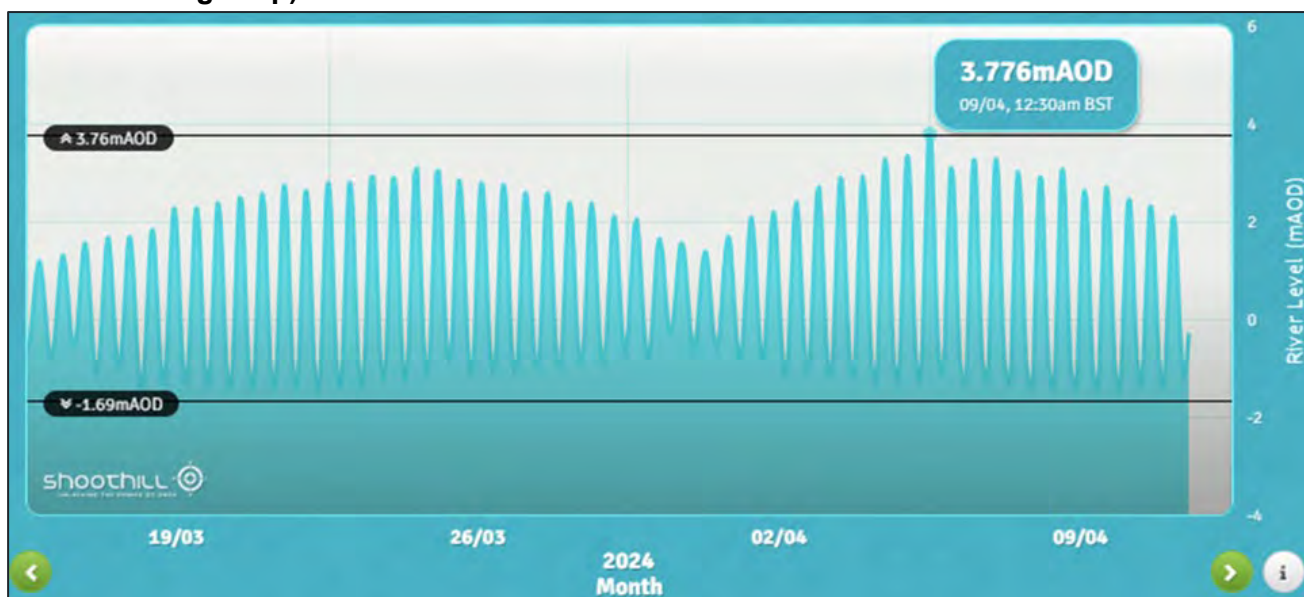
- 3.1.3. A review of the tidal data confirmed that high spring tides were experienced at the time of Storm Pierrick. Figure 3-1 uses data obtained from a gauge on the River Arun in Littlehampton. This gauge records a tidal level, measured from mean sea level rather than from the riverbed. The gauge recorded a peak tide level of 3.776m Above Ordnance Datum (AOD) at 00:30 on the 9th of April. According to the [River Levels website](#), this level is 0.7 m higher than the peak of the typical range seen 90 percent of the time since records began in 1992. Furthermore, the highest level ever recorded at this gauge is 3.8 m AOD, meaning the event of the 8th – 9th April 2024 is one of the most severe the river gauge has experienced on record.

Figure 3-1 - The recorded river level at the tidal gauge on the River Arun in Littlehampton. It indicates a peak river level of 3.776 mAOD at 00:30 on the 9th of April 2024 (Obtained from Shoothill GaugeMap)

- 3.1.4. It is important to note that there is limited information available regarding the reliability of the river gauge. The gauge is owned, operated, and maintained by the Environment Agency, but the River Levels website states that no quality control is applied to its raw data. Therefore, caution should be applied when interpreting the data.

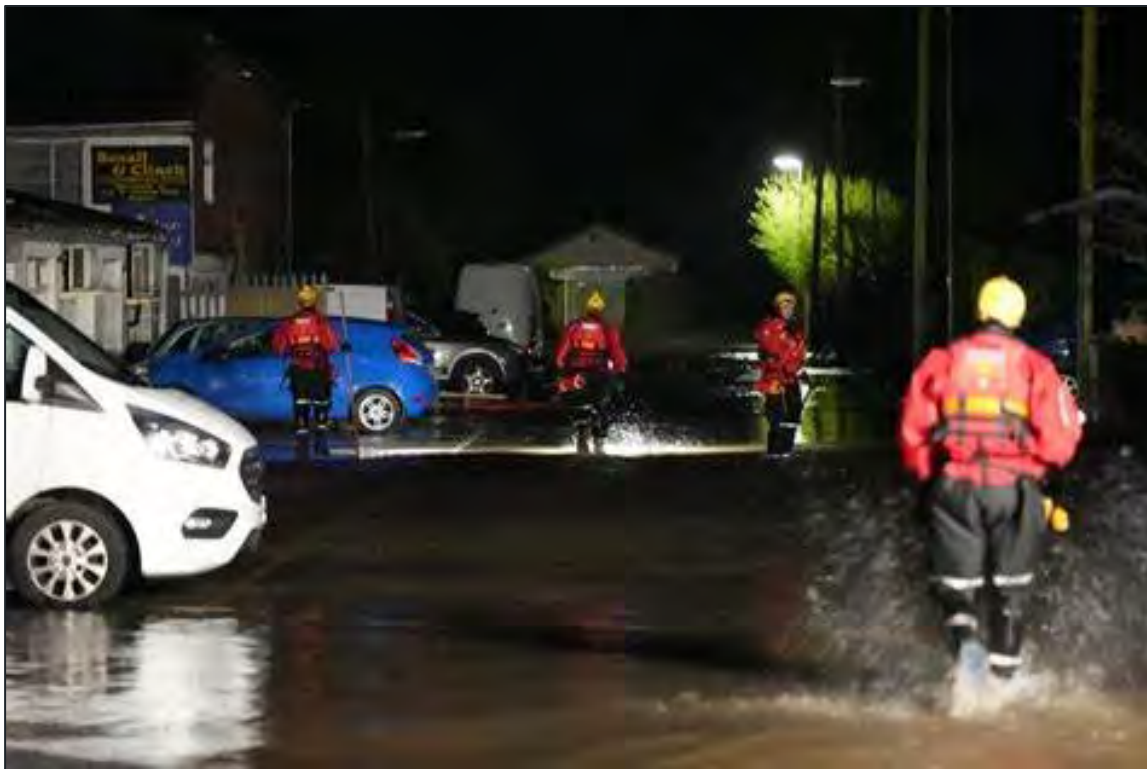
- 4.3.6. An emergency evacuation was carried out through the night by the fire brigade and other emergency services (refer to Figure 4-2). Due to flooding on Ferry Road, residents of Rope Walk were evacuated using the footbridge that crosses the River Arun. This was complicated due to nighttime conditions and the lack of light after a substation at the end of Rope Walk was flooded out. Flooding also put an SSE pumping station in Rope Walk out of service.

Figure 4-2 - Flooding at Rope Walk

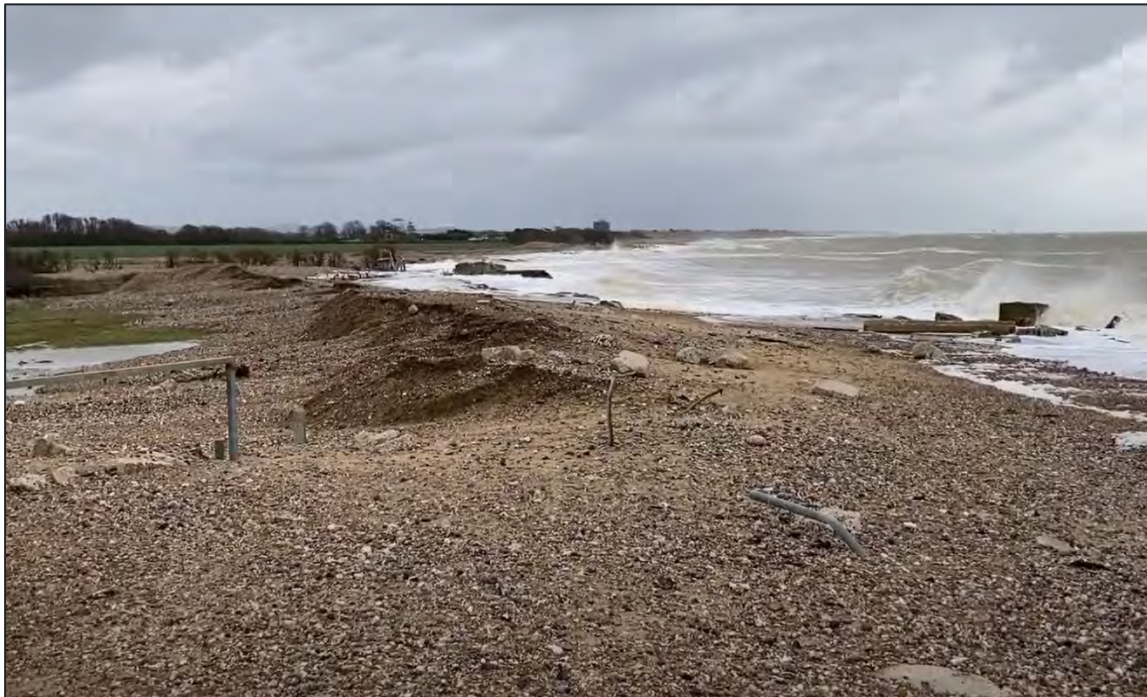
- 5.4.2. During WSP's site visit to Littlehampton, it was reported that shingle beach coastal defences at Climping Beach have degraded over recent years (refer to Figure 5-1). Furthermore, old defences were deemed unsafe and were removed in recent years. These included timber groynes and concrete structures which originally formed part of the car park. Residents believe there has been an increase in flooding since.

- 5.4.4. During the 2024 flood event, the weakened coastal defences were overtopped and seawater flooded into agricultural land behind. This caused backing up of water in the ditch and rife system which in turn contributed to the flooding to Rope Walk and Ferry Road.

- 5.4.5. The Environment Agency confirmed that immediately prior to Storm Kathleen and Storm Pierrick, most of the beach was a 'condition 3 – fair', with the section to the west of WSP's study area being a 'condition 4 – poor'. The Agency's inspector commented that the beach berm, "*is uneven with movement of shingle due to wave attack and vehicle movement creating deep ruts. Crest is very narrow and uneven, with loss of crest suggesting movement of shingle by waves*". The Environment Agency also remarked that, "*the defence is not uniform in condition along its length due to the need for access to be allowed at the Bread Lane byway and access track at Mill Lane. The standard of protection along the frontage ranged between 1 in 50 to 1 in 1 at the gaps in the defence*" prior to the flood event.

Figure 5-1 - Eroded Coastal Defences at Climping Beach (taken 9th April 2024)

- 7.3.1. It is noted that following Storm Kathleen, the Environment Agency replenished shingle at Climping Beach. Therefore, one recommendation of this report is the continued inspection and maintenance of the Environment Agency's coastal defences at Climping Beach to maintain an acceptable level of protection to Rope Walk and Ferry Road from coastal flooding. This area of frontage could be highlighted as a priority, and arrangements could be made for pre-emptive inspections on receipt of forecasts of heavy rain or tidal surges. This will also prevent the infilling of the ditch that runs behind the coastal defences at Climping Beach from shingle that has been washed over during storms.

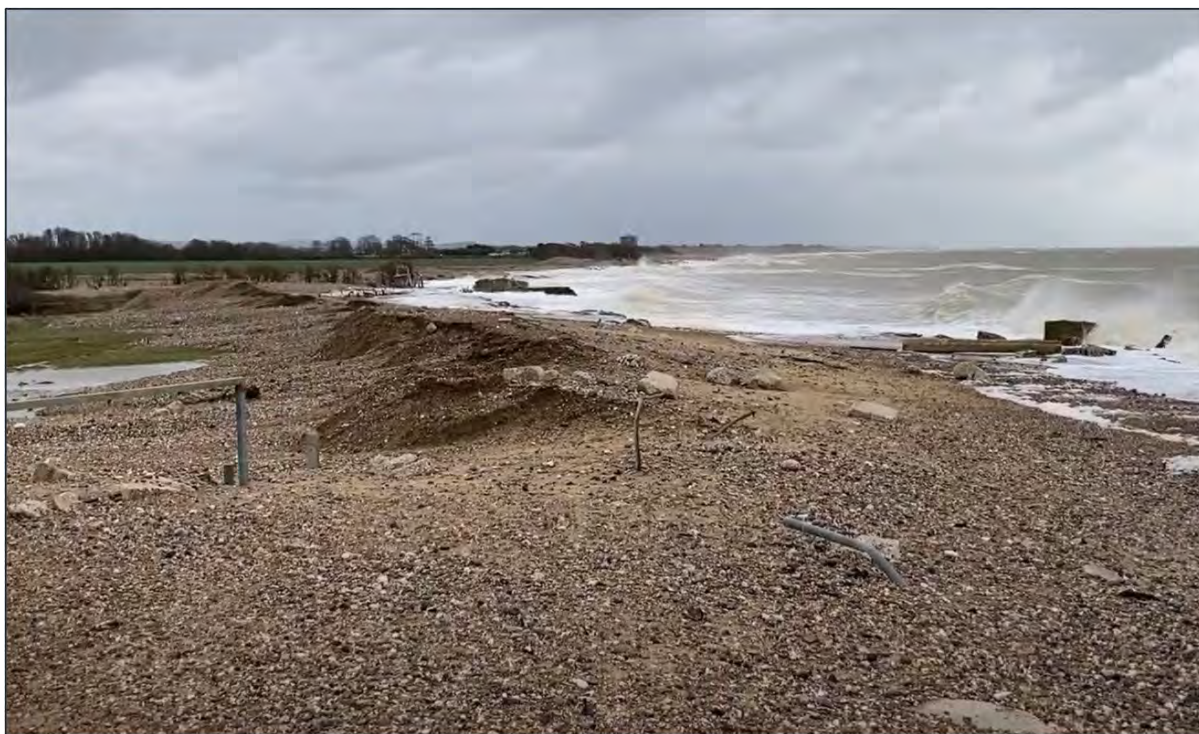
Photo 1 – Climping Beach Seafront taken following Storm Kathleen (Source: [YouTube \(Paulliewallie T\): Climping Beach/Ferry Road Littlehampton - Storm Kathleen 2024 - Coastal Erosion](#))

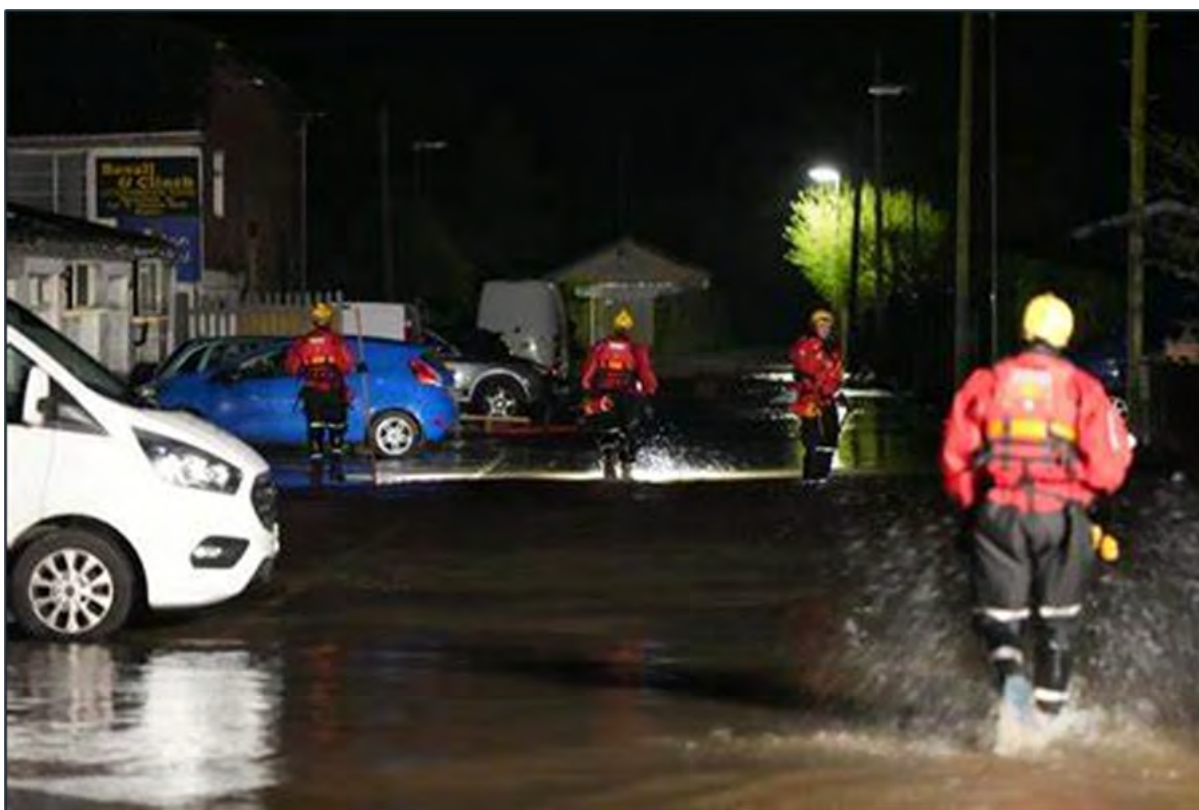
Photo 2 – Rope Walk during the April 2024 flood event (Source: [Sussex Express: Storm Kathleen flooding chaos in Sussex after River Arun bursts its banks and holiday park evacuated](#))

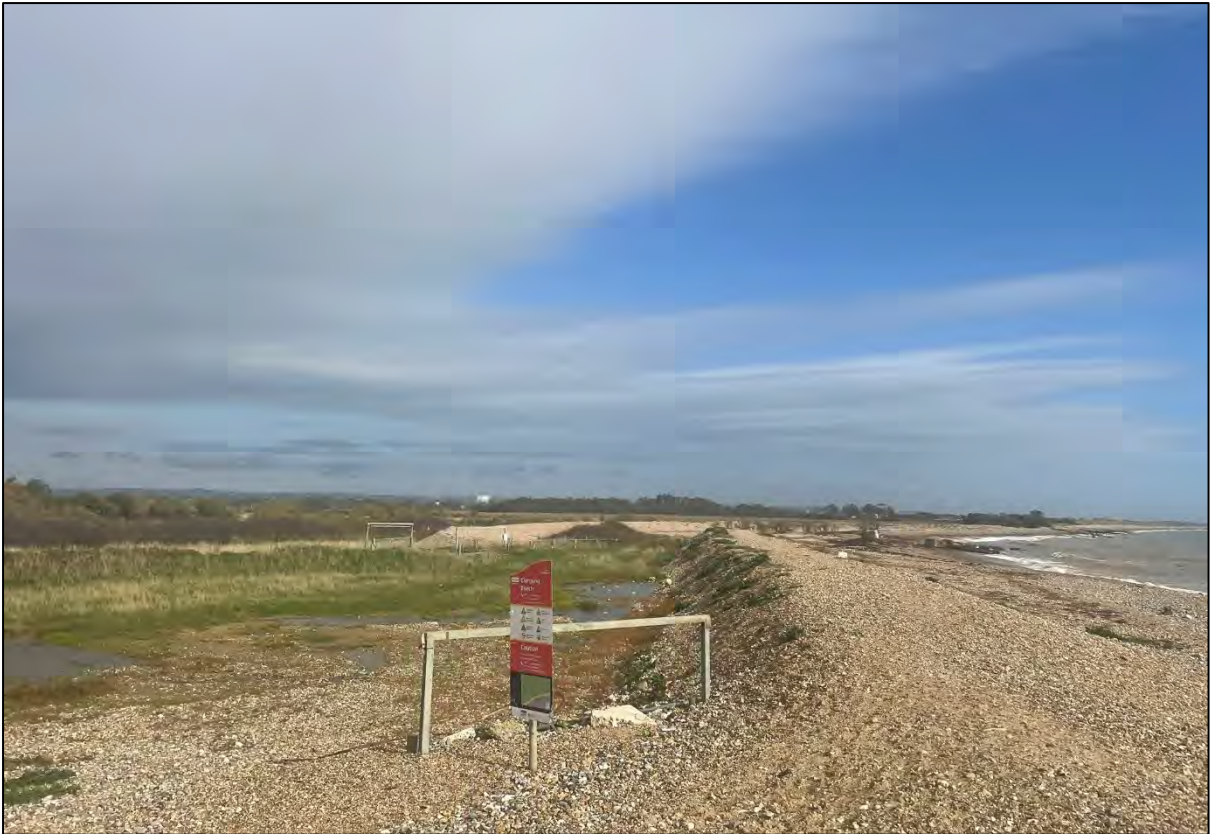
Photo 3 – Climping Beach Seafront taken 16/10/2024

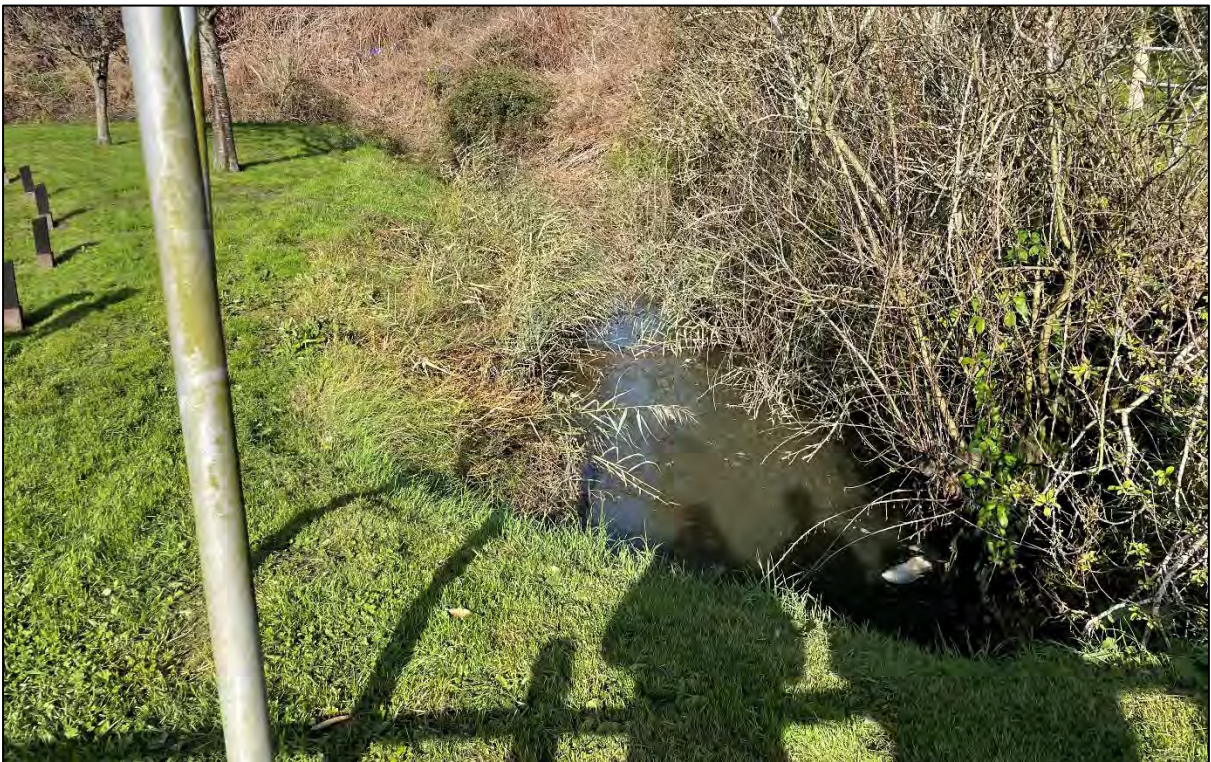
Photo 4 – Rope Walk Ditch taken 16/10/2024

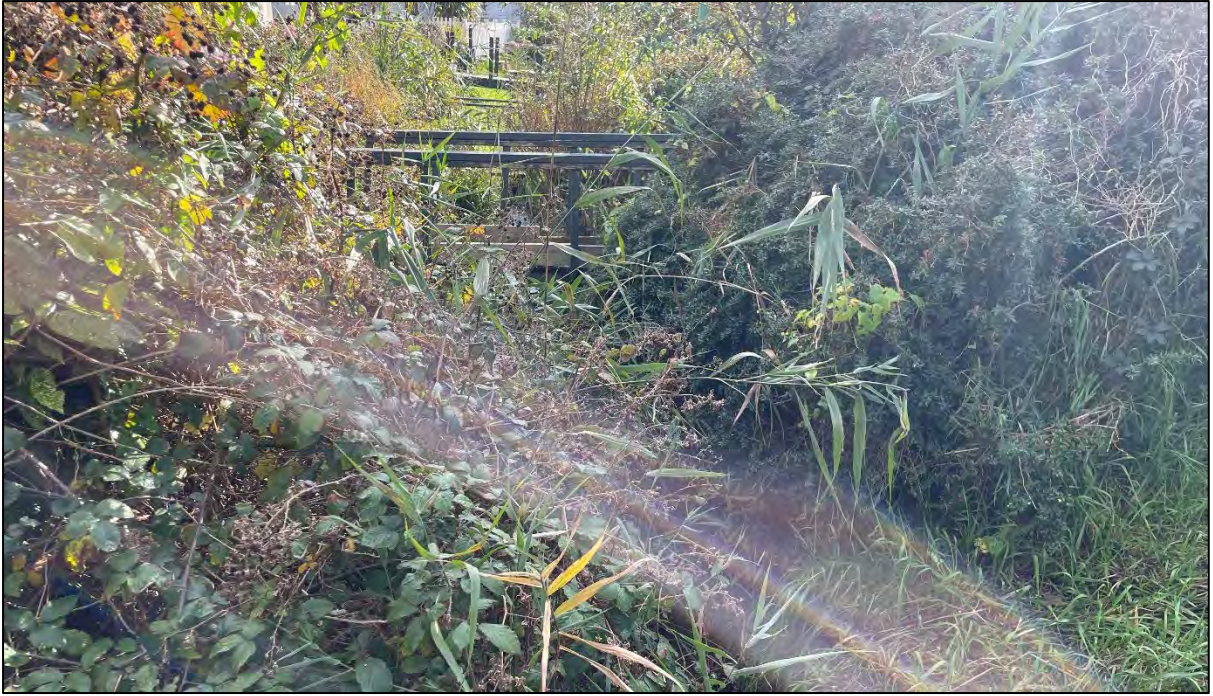
Photo 5 – Rope Walk Ditch taken 16/10/2024

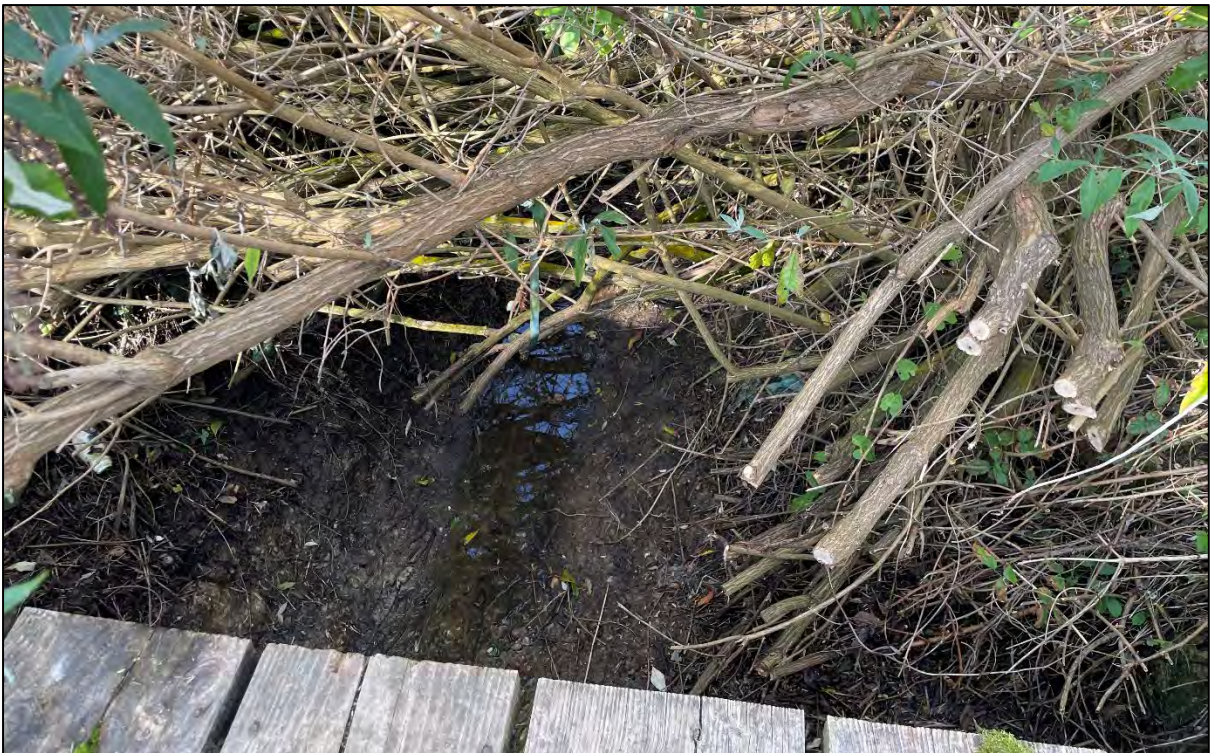
Photo 6 – Rope Walk Ditch taken 16/10/2024

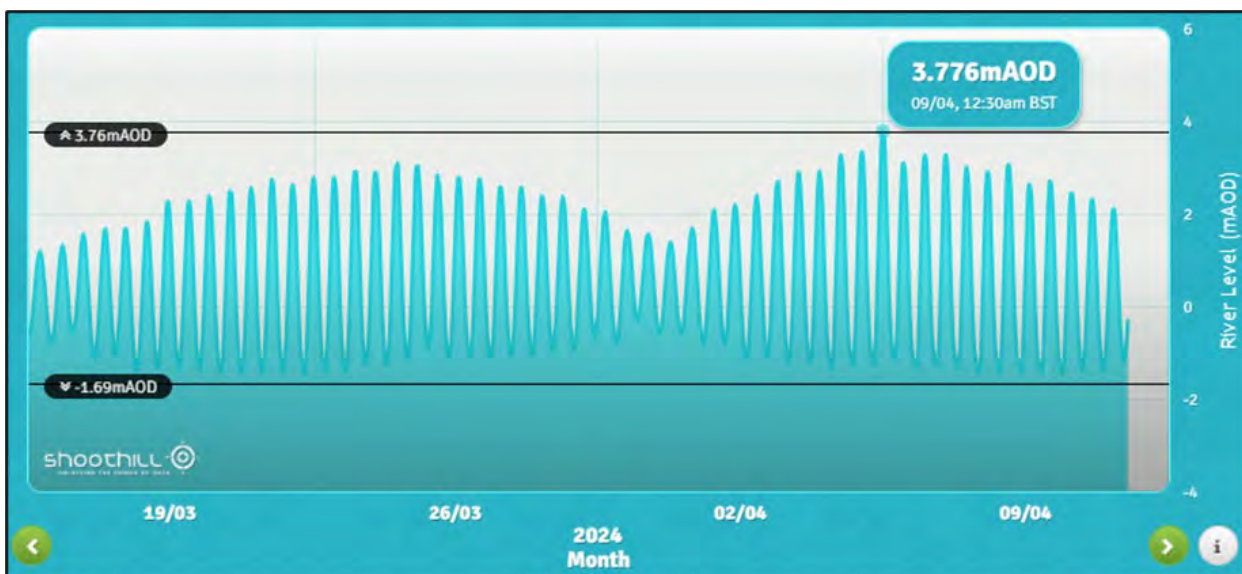
highest level ever recorded at this gauge is 3.8 mAOD, meaning the event of the 8th – 9th April 2024 is one of the most severe the river gauge has experienced on record.

Figure 2 - The recorded river level at the tidal gauge on the River Arun in Littlehampton. It indicates a peak river level of 3.776 mAOD at 00:30 on the 9th of April 2024. Obtained from Shoothill GaugeMap⁷.

However, it is important to note that there is limited information available regarding the reliability of the river gauge. The gauge is owned, operated, and maintained by the Environment Agency, but the River Levels³ website states that no quality control is applied to its raw data. Therefore, caution should be applied when interpreting the data.

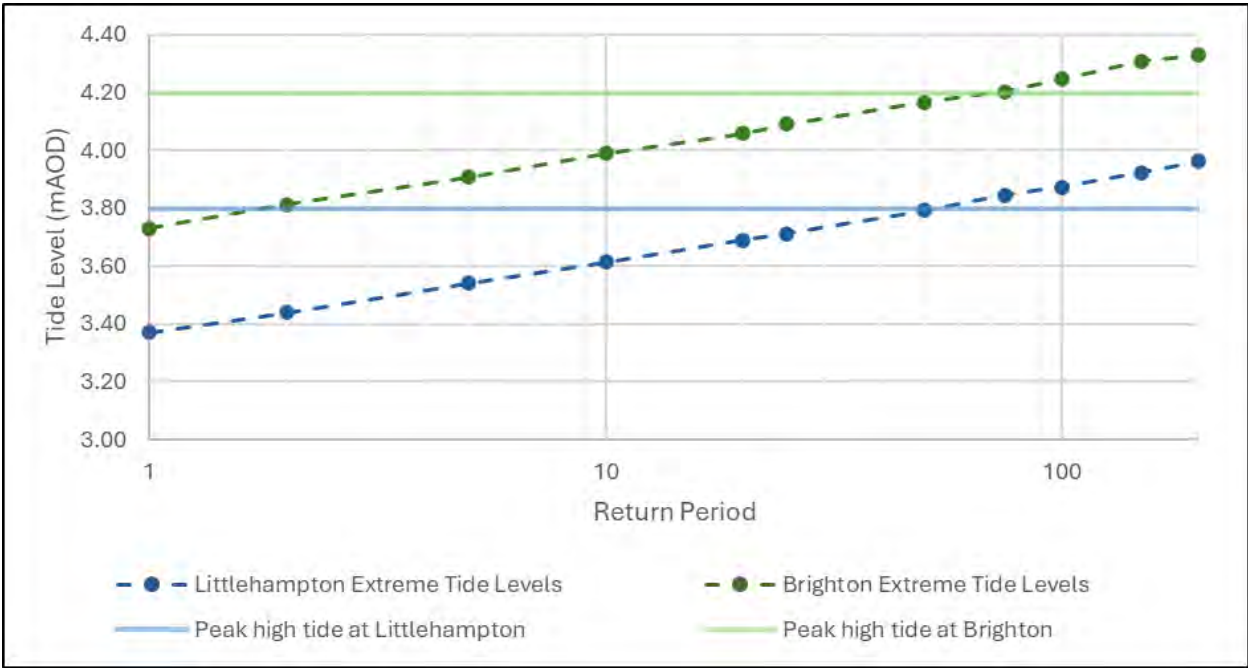
Figure 4- Comparison of recorded peak high tide at Littlehampton (blue) and Brighton (green) against the average extreme water level return periods for both locations obtained from the Environment Agency dataset.

Figure 4 demonstrates that the peak high tide of 3.8 mAOD experienced at Littlehampton is estimated equivalent to a predicted return period of a 1-in-50-year tide along the coast at Littlehampton. It is important to recognise that the gauge at Littlehampton is inland, so the return periods predicted by the EA coastal dataset are not fully representative of those experienced at the gauge location or at Rope Walk.
