S19 Flood Investigations

Storm Kathleen – Medmerry & Bracklesham, April 2024

Storm Kathleen, April 2024

REPORT (ISSUE 1) PUBLIC

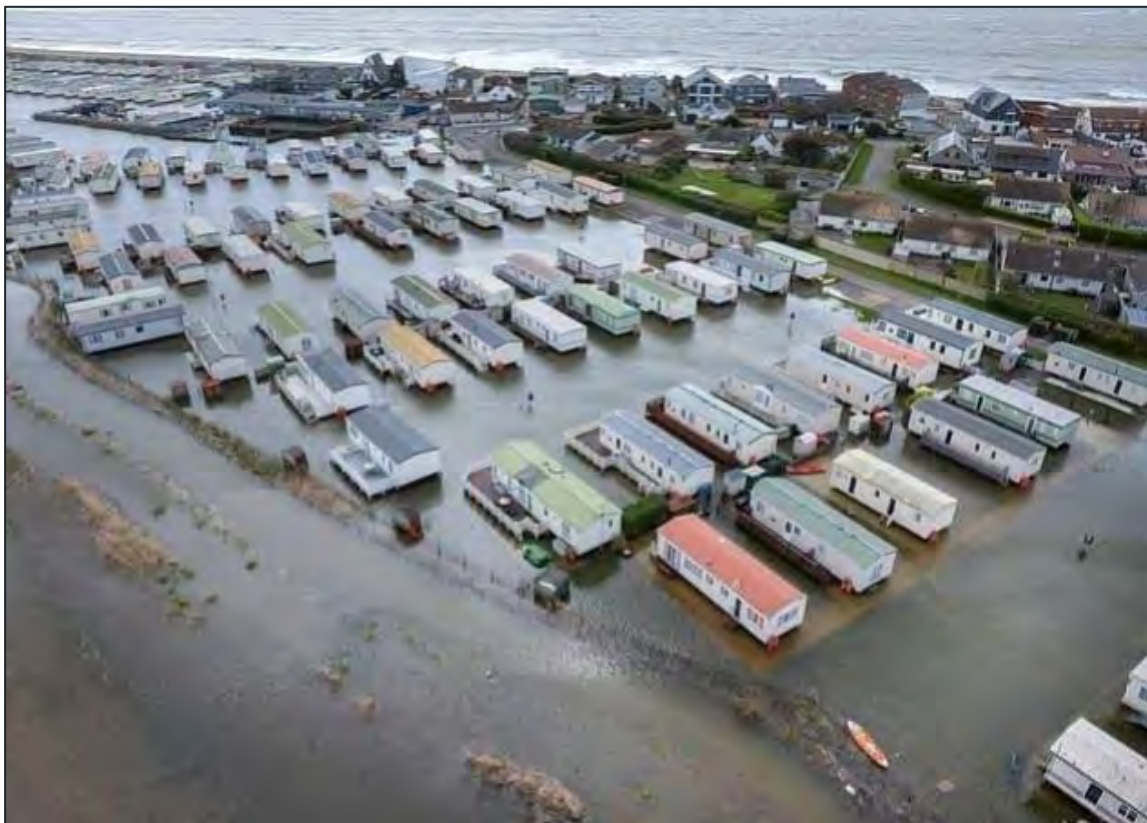
Figure 4-2 - Flooding at Bracklesham Caravan & Boat Club (taken 09/04/2024)

- 4.2.5. From interviews with employees at Bracklesham Caravan & Boat Club, it is understood that the flooding occurred at approximately 1am on the morning of the 9th of April 2024. The flooding occurred a few days after Storm Kathleen, which caused heavy rainfall, and during Storm Pierrick, which caused a strong tidal surge. The main source of flooding is understood to have been sea water which overtopped the Environment Agency's coastal defences at Medmerry and flooded land behind the defences, including the Earnley Rife. This caused flows in the Earnley Rife to back up and come out of bank adjacent to the club.

- 4.2.11. Immediately prior to the flood event, approximately 30 caravans were occupied. Some occupants chose to evacuate the site following receipt of a warning issued by the Met Office in the afternoon preceding the event. During the flood event itself, however, the club experienced a power cut and an overnight evacuation was not conducted because it was deemed unsafe, although some occupants were evacuated from the caravans to the club's office.

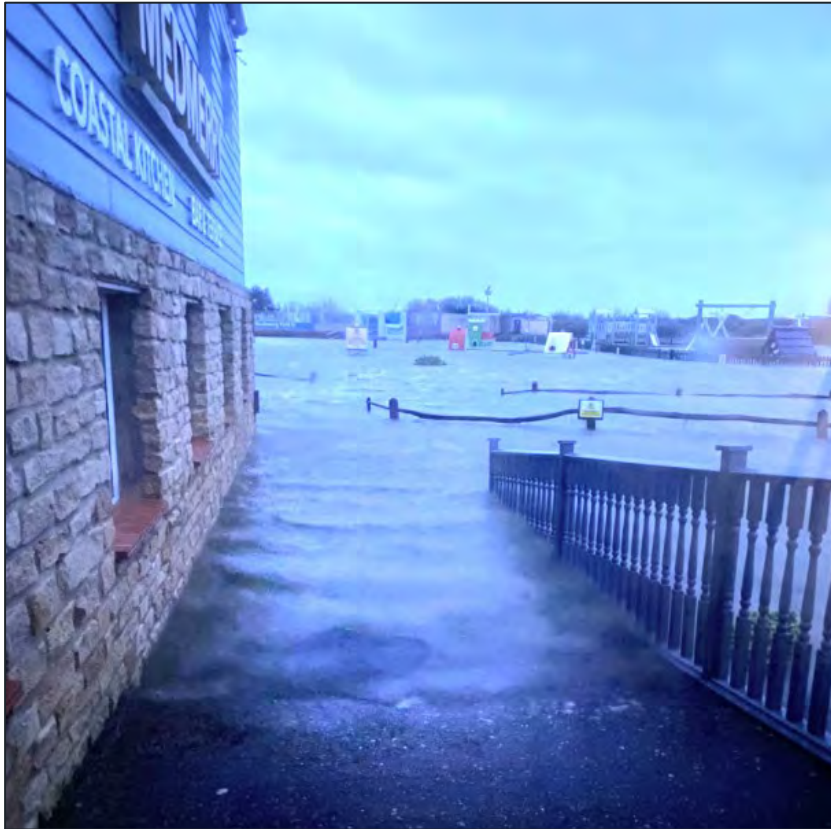
Figure 4-4 - Flooding at Medmerry Cove Seaside Park (taken 09/04/2024)

- 4.3.5. From interviews conducted with employees at Medmerry Cove Seaside Park, it is understood that the flooding began at approximately 12:30am on the morning of the 9th of April 2024. It occurred a few days after Storm Kathleen, which caused heavy rainfall, and during Storm Pierrick, which caused a strong tidal surge.

- 4.3.7. Employees reported that of the 268 chalets at the park, approximately 233 were flooded internally. It was also reported that a substation failed, causing a loss of power to the site. Employees began moving guests to areas of higher ground soon after the flooding started until the coastguard arrived to support evacuation from the site at approximately 3am. Approximately 150 people were evacuated to the onsite pub initially. Eventually, approximately 230 people in total were evacuated offsite. The fire and ambulance services were also reportedly in attendance during the flood event, and one person was taken to hospital suffering from exposure. The site was fully evacuated by 6am on the 9th of April.

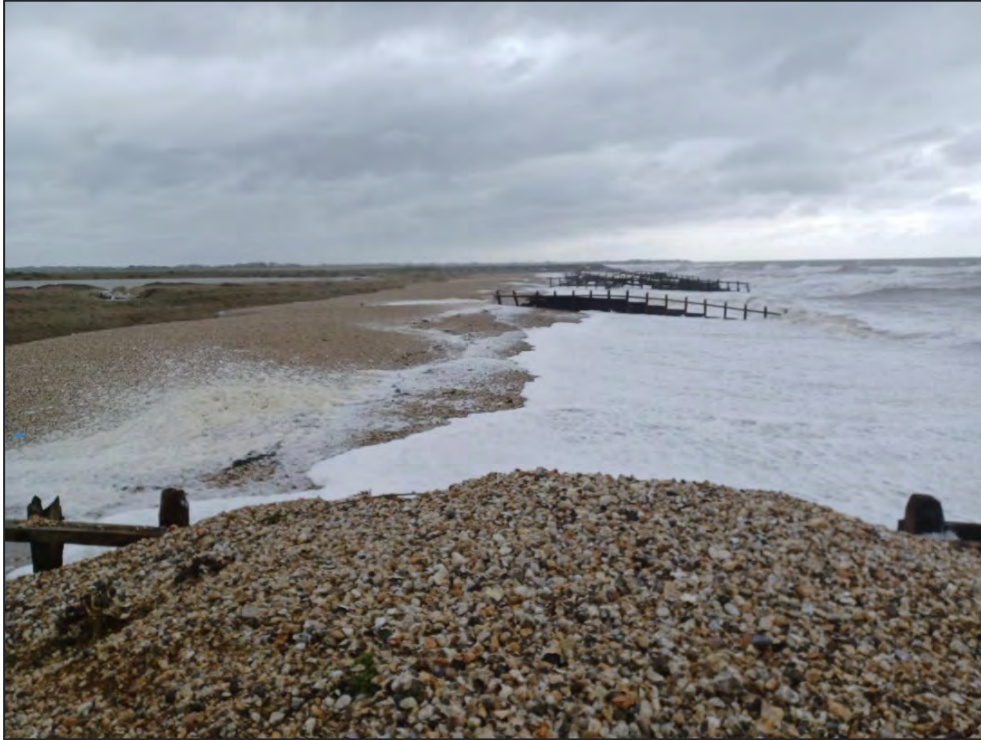
Figure 5-4 - Environment Agency's Sea Defence at Medmerry (taken 09/04/2024)

- 5.4.9. The strong tidal surge in April 2024 allowed seawater to overtop the defences at Medmerry West Beach, possibly causing further damage to them, and flood inland, inundating Medmerry Cove Seaside Park and the Earnley Rife which itself caused backing up of flows in the Earnley Rife which culminated in overtopping of the rife and flooding of Bracklesham Caravan & Boat Club.

- 5.4.10. Figure 5-4 below shows the condition of the defences on the morning of the 9th of April 2024, after the flood event. Figure 5-5 below shows the appearance of the defences at the time of WSP's site visit on 2nd October 2024.

- 7.3.1. The most significant recommendation of this report is that the Environment Agency could consider replenishing or upgrading their sea defences, increasing the full length of defence to a level matching or exceeding the adjoining CDC defences to the west, thereby increasing the level of protection currently afforded to both sites.
- 7.3.2. Furthermore, it is recommended that the Agency could investigate the reason for the removal of the flap valve that is believed to previously have been in place along the Earnley Rife (refer to Section 5.5). The Environment Agency could consider reinstating the flap valve to prevent surcharging of flows in the rife, as was seen in April 2024. Modelling may be required to ensure that mounting a

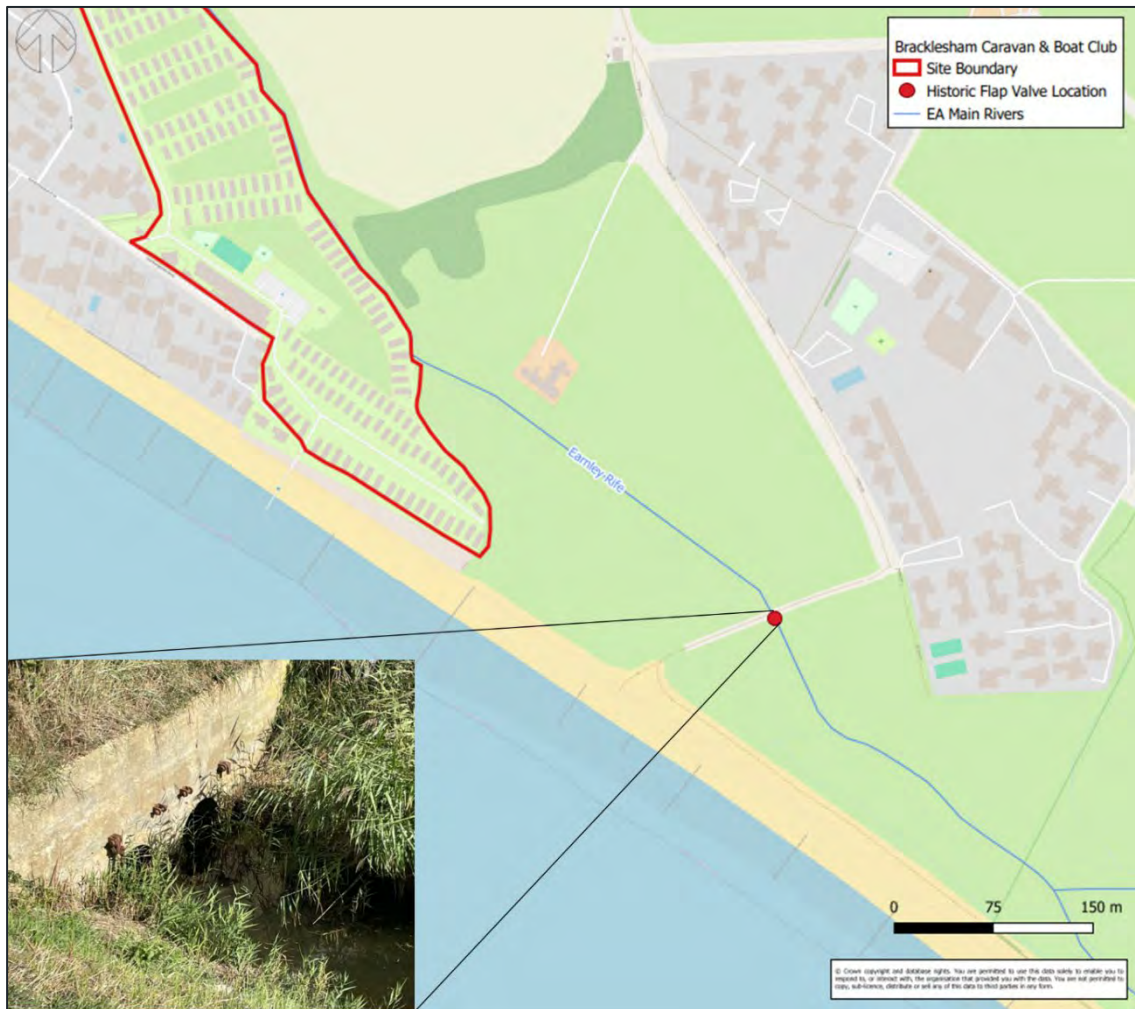
Figure 5-6 – Earnley Rife Culvert Location (note flap valve mountings on inset image)

- 5.5.1. During WSP's site visit to Bracklesham it was noted that one of the culverts conveying the Earnley Rife below an access track to the south of Medmerry Sea Cove Park had mounting points for a flap valve. This suggests that a flap valve was previously fixed to the headwall to prevent water backing up the Earnley Rife in the event of seawater inundating the rife further downstream. Refer to Figure 5-6. The reason for the absence of the flap valve is not known, however it could have contributed to the flooding of Bracklesham Caravan and Boat Club.

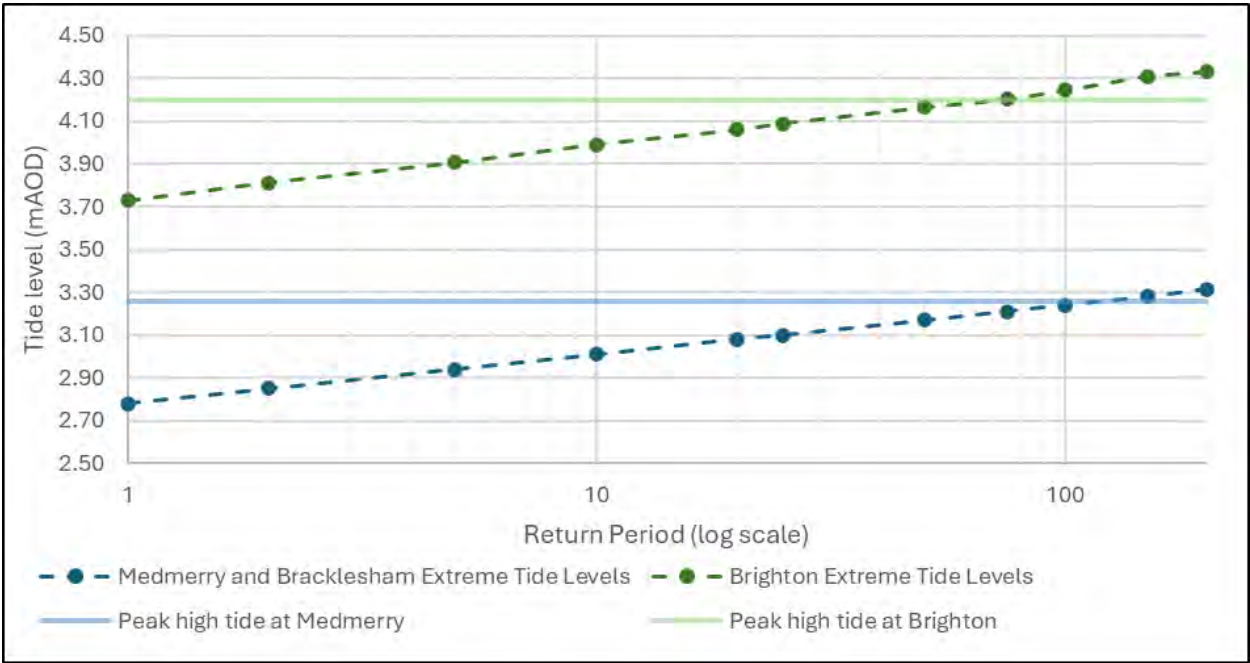
Figure 4 - Comparison of recorded peak high tide on 9th April at Medmerry (blue) and Brighton (green) against the extreme water level return periods obtained from the Environment Agency dataset.

Figure 4 demonstrates that the peak high tide of 3.26 mAOD experienced at Medmerry is estimated equivalent to a return period of a 1-in-100-year tide according to an average of the Environment Agency’s Coastal Flood Boundary Dataset points along the coast at Medmerry and Bracklesham. Similarly, at Brighton, the experienced peak high tide of 4.19 mAOD is estimated equivalent to the average 1-in-75-year tide along the coast at Brighton.
